12
TECHNICAL REPORT M-207
March 1977

COATINGS AND CATHODIC PROTECTION OF PILINGS IN SEAWATER:
RESULTS OF 5-YEAR EXPOSURE

by
D. E. Wittmer
A. Kumar

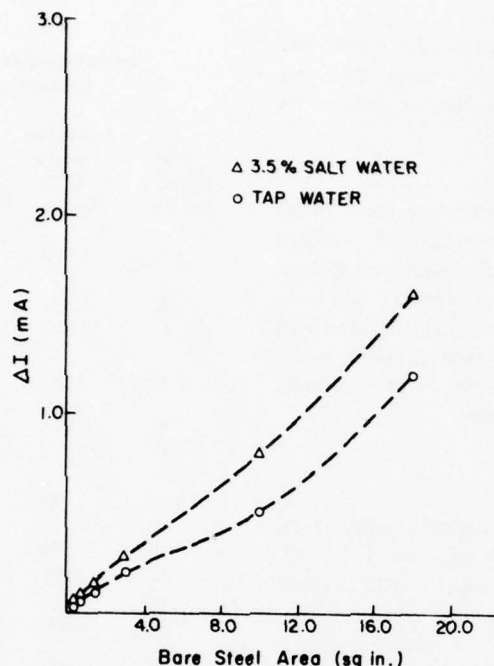
Recent laboratory investigations of vinyl and coal-tar epoxy coatings and bare steel immersed in tap and salt water at CERL have demonstrated the direct correlation between change in current and change in bare steel area (Figure 7). Since CPI is inversely proportional to the change in current (by Eq 1), a direct correlation exists between CPI and bare steel exposed to an aqueous medium. A decrease in CPI is indicative of a larger area of bare steel exposed to water (larger change in current required); a decrease in CPI is therefore an indication of coating deterioration.

Figure 7 also demonstrates the need for higher currents for cathodic protection in salt water, which is more corrosive than tap or fresh water; thus, the magnitude of the CPI also depends on the test or service environment.

Figure 7. ΔI as a function of bare steel area in tap and salt water. SI conversion factor: 1 sq in. = 6.4156 cm².

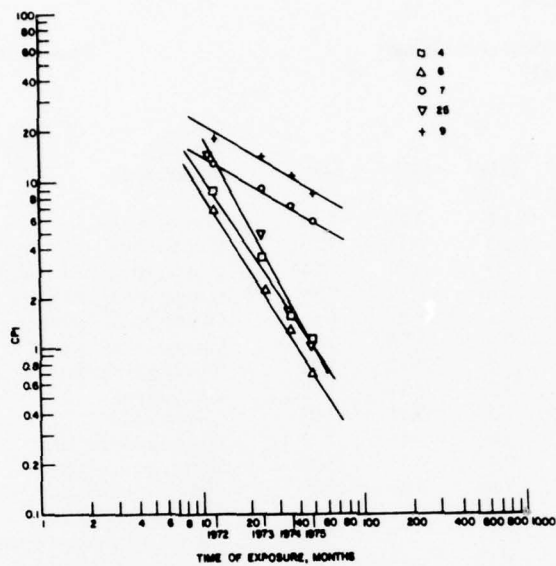
Plotting the cathodic protection indices vs. time durations on log-log plots (Figures 8 through 11) permits prediction of the deterioration of the coatings over a long period of time. Deterioration of the coatings generally resulted in a drop in CPI, as demonstrated by a negative slope averaging approximately -0.65 for all coatings (Figures 8 through 10). However, some coatings, such as flame-sprayed metalics, have a completely flat slope or a slightly positive one, indicating formation of protective corrosion products, such as aluminum oxide or zinc oxide, in the porous flame-sprayed metal. All other systems show negative logarithmic behavior, with decay of index m depending

Comparison of Table 6 and Figures 8 through 11 shows a very strong correlation between the rank of the effectiveness of protection and CPI for all independent generic systems. Only in the category of organic over metal-filled coatings is the correlation weakened, possibly because of the difference in conductivity of the various metal-filled undercoats.

Figure 8. CPI as a function of time of exposure for organic coating systems.

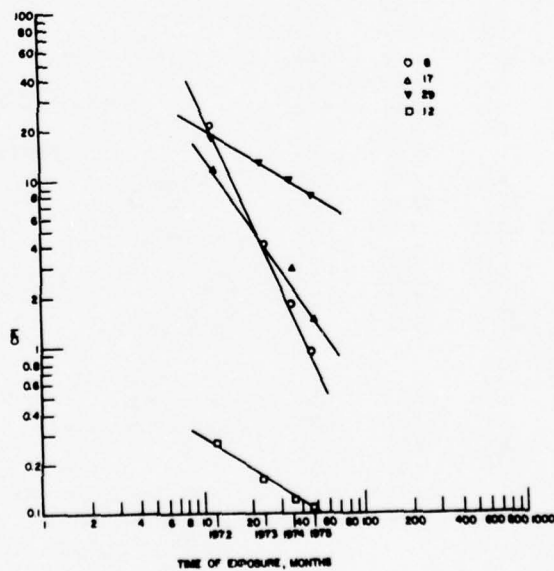
Figure 9. CPI as a function of time of exposure for miscellaneous organic coatings and metal-filled organic coating systems.

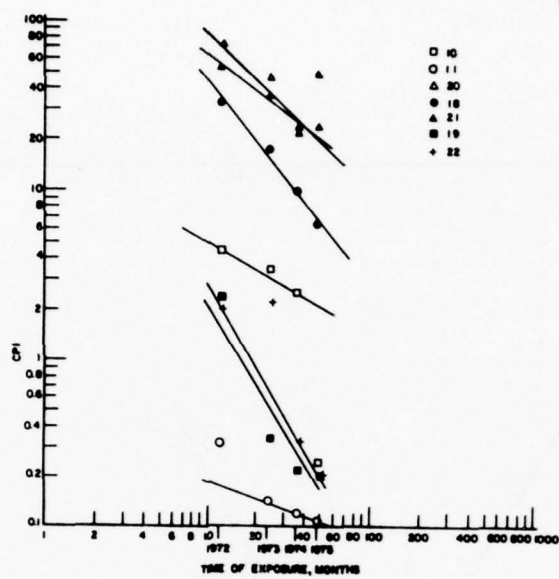
Figure 10. CPI as a function of time of exposure for organic over metal-filled coating systems.

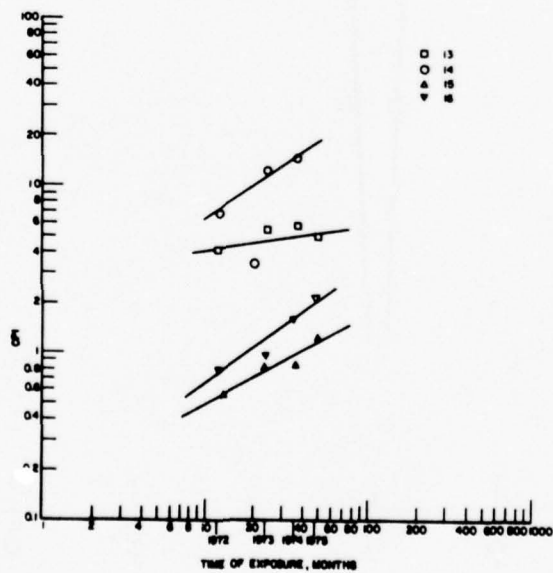
Figure 11. CPI as a function of time of exposure for metallic and organic over metallic systems.

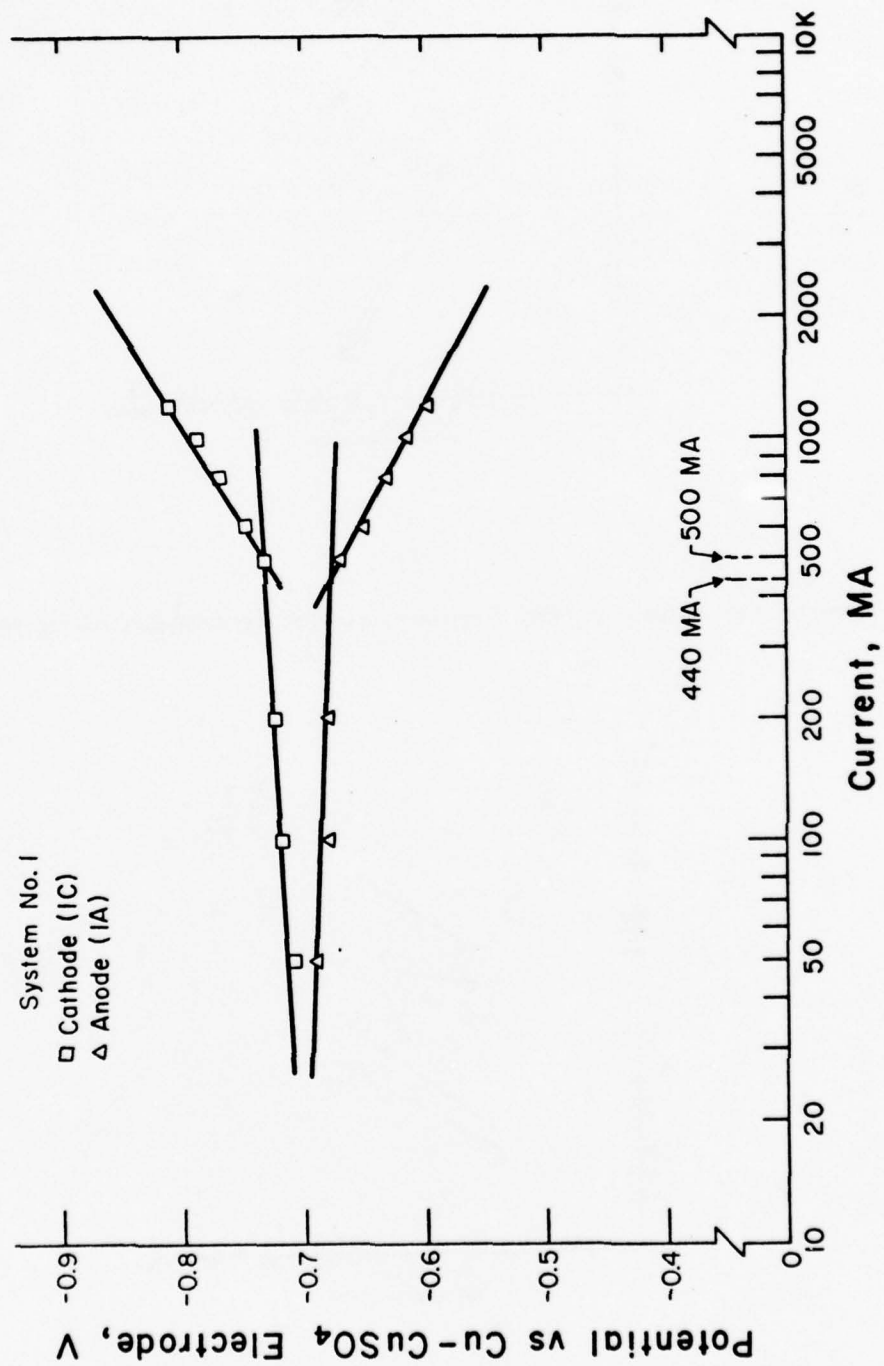
metal loss or the corrosion rate. Table 10 summarizes the corrosion current densities per square foot, based on Schwerdtfeger's equation (Eq 2), for systems 1, 7, and 28. Determination of I_p and I_q was accomplished by extending the tangents of linear portions of the curves and determining their intersection, as shown in Figures 12 through 14.

Figure 12. Polarization curves for system I.

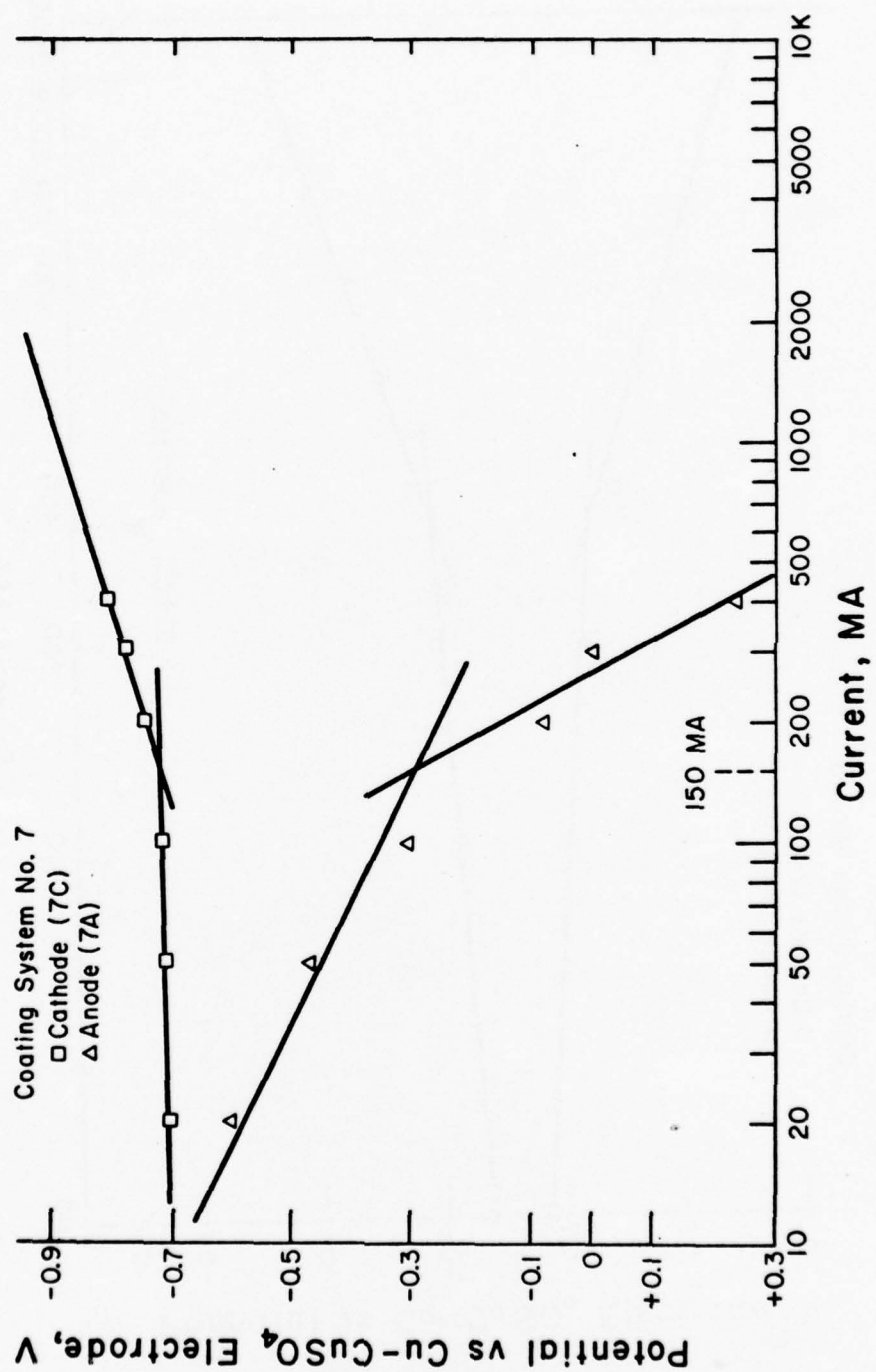
Figure 13. Polarization curves for system 7.

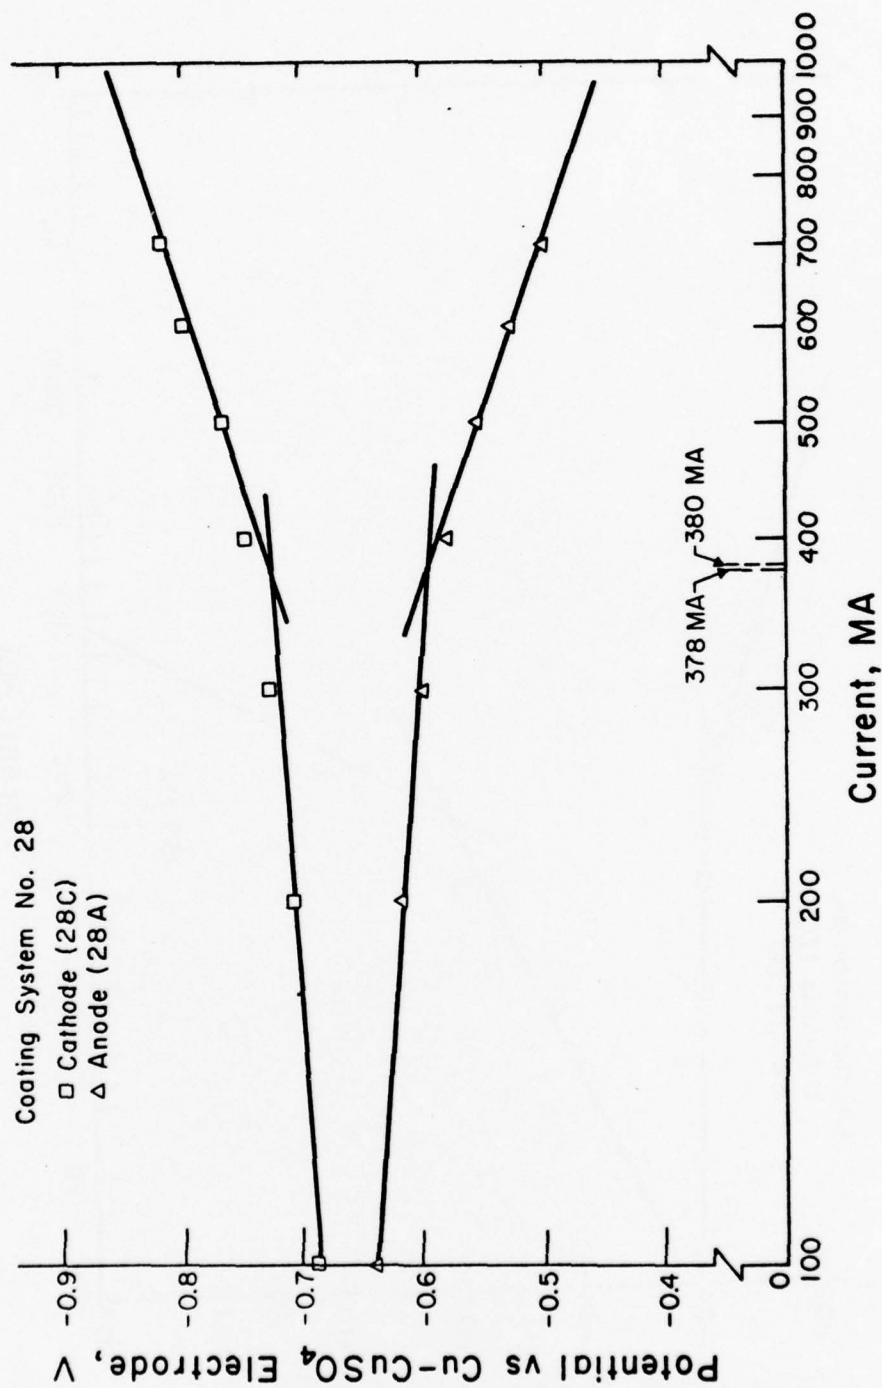
Figure 14. Polarization curves for system 28.

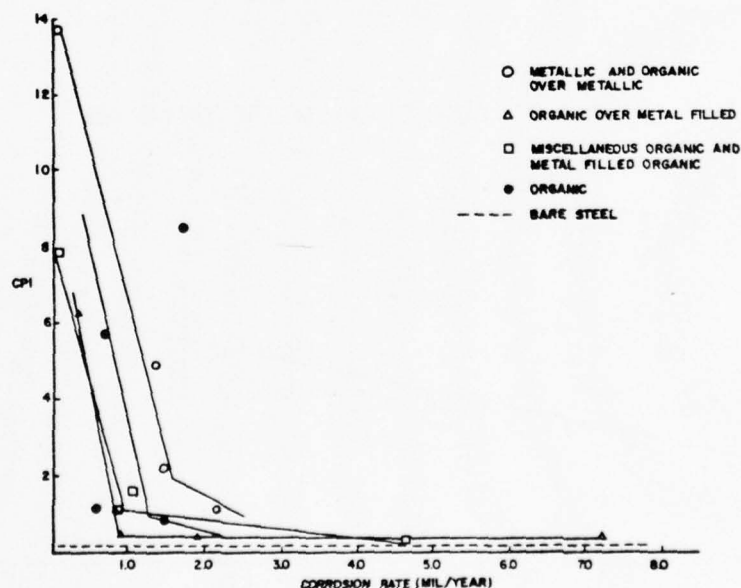
Figures 22 and 23 show the cathodic protection index¹¹ as a function of corrosion rate for the LaCosta Island and Dam Neck pilings, respectively. The data from both sites reveal sharp declines in CPI with increasing corrosion rate for each independent generic system. At low corrosion rates, the CPI appears to depend on the specific generic system, while high corrosion rates are associated with low CPI, regardless of the generic system. The bare steel baseline was included to indicate the low CPI coupled with the high corrosion rates generated by the bare steel, in comparison to any of the coating systems. The correlation between CPI and corrosion rate was determined by computer analysis to be 80 percent for all systems.

Figure 22. Cathodic protection index as a function of corrosion rate for LaCosta Island pilings. SI conversion factor: 1 mil = 0.0254 mm.

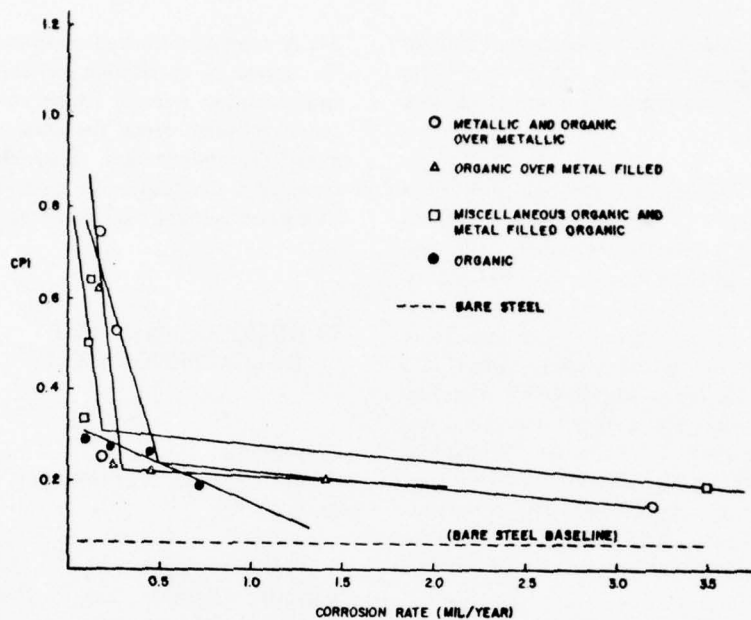
Figure 23. Cathodic protection index as a function of corrosion rate for Dam Neck pilings. CPI data were obtained from M. Romanoff, et al., "Protection of Steel Piles in a Natural Seawater Environment," *Proceedings, Third International Congress on Marine Corrosion and Fouling* (1973), and corrosion rates from E. Escalante, et al., *Protection of Steel Piles in a Natural Seawater Environment—Part II*, NBSIR 76-1104 (National Bureau of Standards, 1976). SI conversion factor: 1 mil = 0.0254 mm.

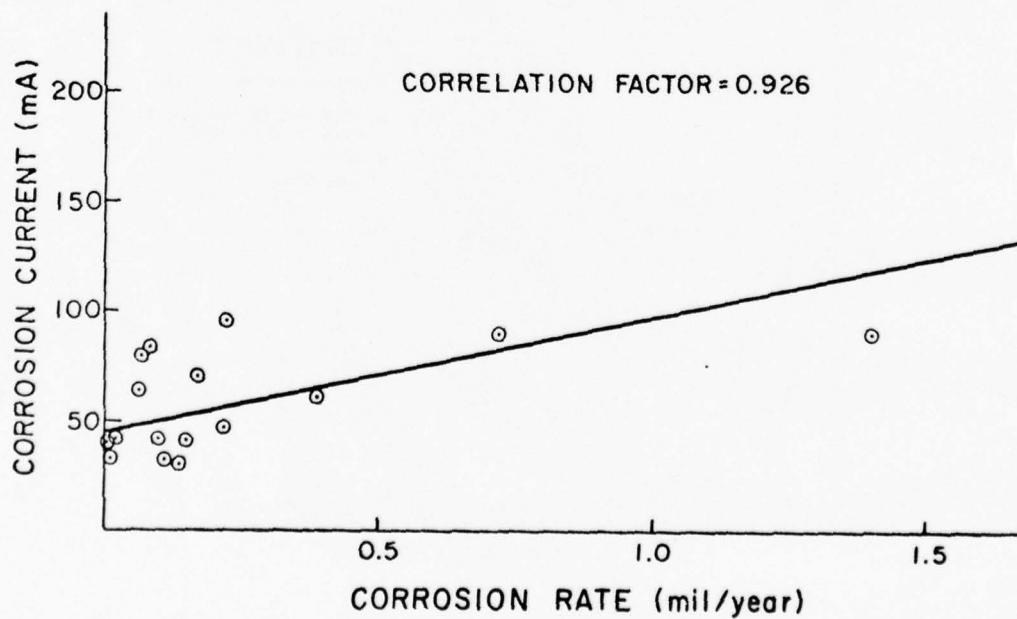
Figure 24. Corrosion rate vs. corrosion current. SI conversion factor: 1 mil = 0.0254 mm.
